FIRST NATIONAL BANK BUILDING

3. HISTORICAL OVERVIEW

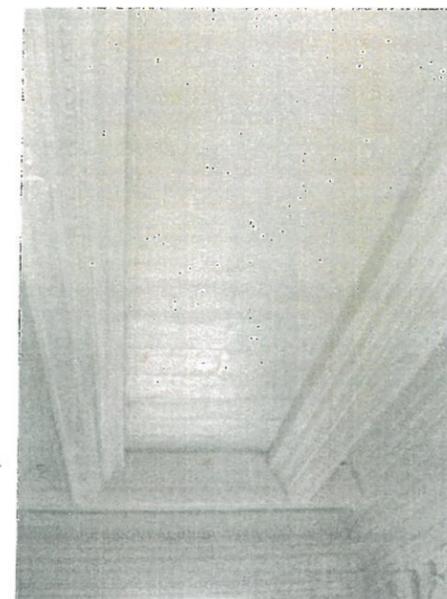
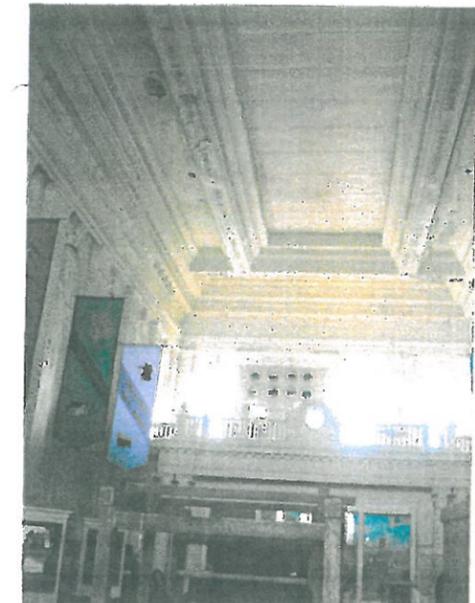
Skylight Boarded up Inside

Another important feature of the building is the skylight which was damaged during the fire. It will be necessary to uncover it both internally and externally before deciding on the extent of renovation work it will require. There can be little doubt however that if the building is kept as a single volume, the restoration of the skylight would make the interior of the building quit unparalleled in its grandness, especially if kept as a museum or used as a rail station.

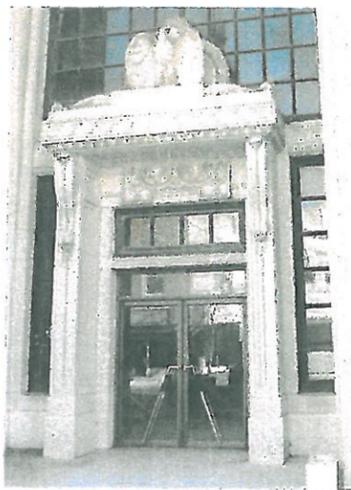
The windows to the front of the building appear to bronze framed single glazed windows but the front door is a pair of aluminum framed glazed doors with a fanlight that are not original.

Doors and Transom Changed After Fire

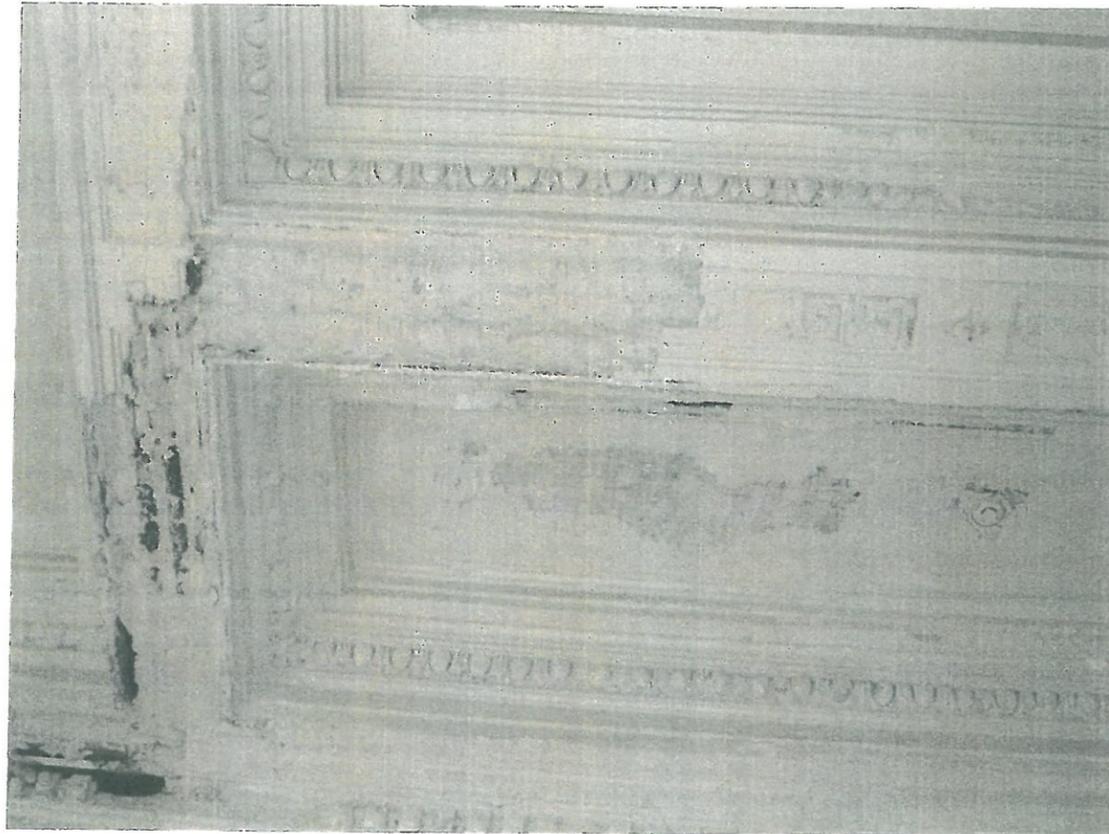
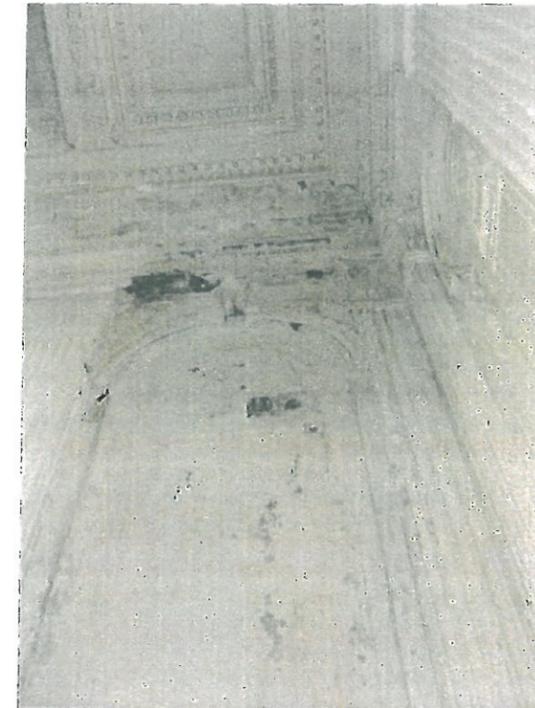
- The most devastating damage was to the ornate plasterwork of the interior. Heat badly damaged the right side of the ceiling especially at the rear corner. Extensive water damage then resulted from the fire hoses. The plaster must have absorbed massive quantities of water and there is extensive efflorescent damage, with the plaster blooming and falling off. Many of the medallions, corbels and cornice moldings were knocked off by water pressure and have since fallen due to lack of adhesion caused by efflorescence. There has since been considerable slow, long term water damage to the ceiling, especially to the right side of the buildings, caused by water ingress from the roof.

Shots of the Fire and Water Damage

The plasterwork is so badly degraded that it is almost impossible to repair it without hacking off large areas and re-plastering, and the majority of the cornices and dentils etc. are missing and would need replacing. It is estimated that if the plasterwork was restored to its original condition, that this work alone would cost well over \$500,000.

An option, while being less acceptable from a historical restoration point of view, would be to hack off the plaster and replace it with sheetrock. Various layering and building out of a timber framework could re-create the wall conditions; and simple cornice moldings and limited "off the shelf" decorative components would help renovate the interior surfaces while keeping an indication of what existed previously.

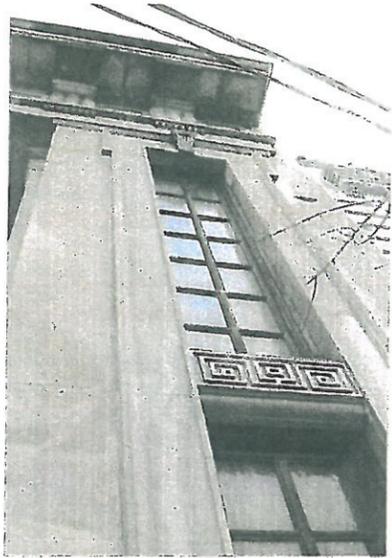
Water Streaming Down Façade

The roof structure created a large 'ditch' like gutter down the two side parapet wall of the building. Each gutter has a single outlet at the front of the building and the right hand outlet had become blocked creating a massive amount of standing water along the entire length of the building some 2+' deep at the low end. Although there were overflow outlets, they were higher than the water level and thus the water was trapped and had been leaking through the roof covering for many months, maybe even years.

The outlet was unblocked and the water emptied out in a matter of minutes. Regrettably, it took our camera with it as it fell down the side of the gutter and disappeared down the outlet pipe. Consequently we do not have photographic evidence of the state of the roof. Fortunately, Frank Frazier, the City Engineer, was with us on the roof to bear witness to this inspection.

The steps taken to mitigate the water damage have taken away the immediate major causes of the buildings degradation. However, there are obviously leaks in the roof covering and as part of any renovation work, the roof should be re-covered.

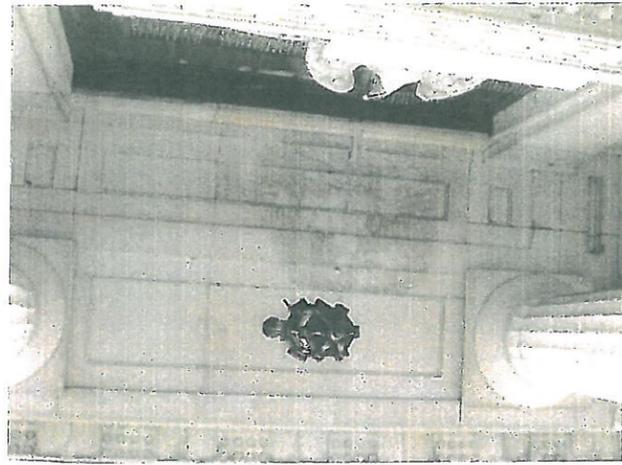
Water Patch on Soffitt of Entrance Porch

There is also a 3' square access hatch in the front center of the roof that is approached by a steel ladder from the ceiling of the porch some 12' below. The hatch had been left off the opening for a considerable period of time that has resulted in the damp patch on the stone ceiling over the porch. The hatch was placed back in position which should prevent any further deterioration.
