FIRST NATIONAL BANK BUILDING

3. HISTORICAL OVERVIEW

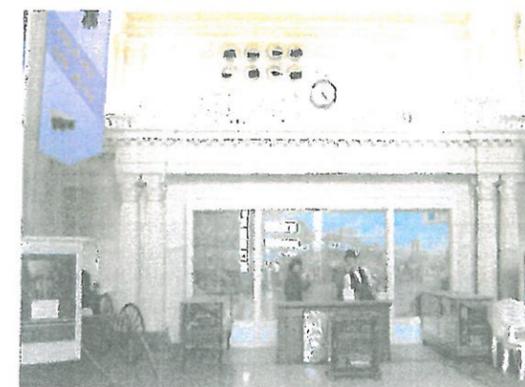
Platform at Rear of Building

The building remained unused for some time before being taken over and used for museum purposes when a large central heating and air conditioning units was placed on the platform and designed to crudely throw conditioned air into the overall space.
